TROY C. HARRISON
 Residential and Commercial Property Inspections
 A Member of the Real Estate Inspection Group, Inc.
 www.inspectiongroup.com

PROPERTY INSPECTION

Inspection Address: 1481 Phantom Avenue

Inspection Date: March 17, 2011

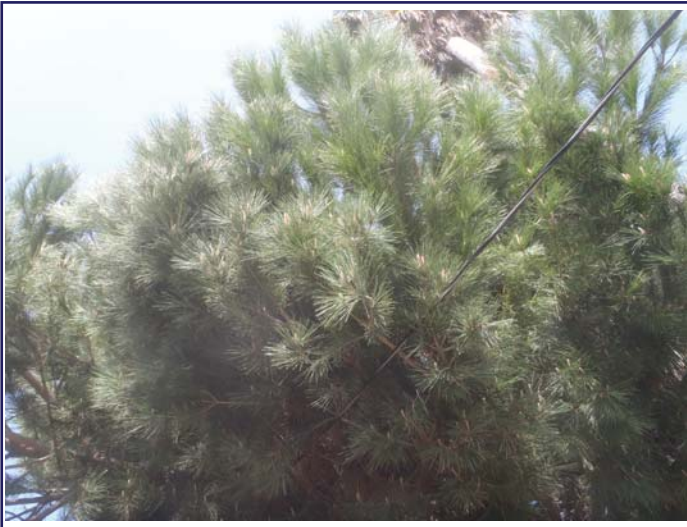
Photo 1

Main electrical cables in contact with tree branches

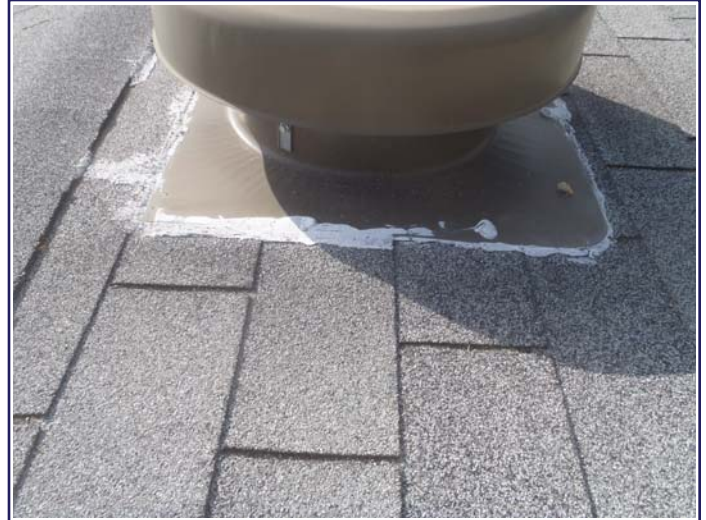
Photo 2

EXTERIOR 1 ACTION ITEMS: 1) The roof covering was an asphalt composition shingle installation and overall appears in good condition. However, the roof jack for the fan above the rear of the house was not properly installed, also I recommend re-sealing around the plumbing vents and roof jacks. In addition, the slope of the roof was not verified. Asphalt shingles may be installed on slopes as low as 2 units vertical in 12 units horizontal, provided the shingles are self-sealing and installed with an underlayment of two layers of non perforated type 15 felt. Have a licensed roofing contractor reinspect the roof covering and perform routine maintenance and corrective repairs as needed. 2) There were no gutters installed around the perimeter of the house. An upgrade would be to install gutters, for drainage control of the roof run-off water. 3) The garage-to-laundry room door is not a fire rated door. A worthwhile upgrade is to install a fire rated solid core door that is equipped with self closing hinges, to give a better fire barrier between the garage and the living portion of the house. 4) There was damage to the garage door jamb, at the laundry room (See the structural pets report for further information and possible repairs). 5) The single pane windows overall appeared in good condition. However, there was worn and deteriorated putty around the exterior of the window frames. In addition, single pane type windows are considered outdated by current building standards. Consider upgrading the windows with double pane type for improved energy efficiency. Consult with a licensed glazing contractor for further evaluation and to perform corrective repairs as needed. 6) Care needs to be exercised around the non safety glass in the garage side door. All new glazing in doors, glass within 12" of the sides of door, and glass within 18" of the floor needs to be safety glass to prevent possible injury from occurring. An upgrade would be to have this corrected. +

Attic fan/flashing above the rear of the house is not properly installed

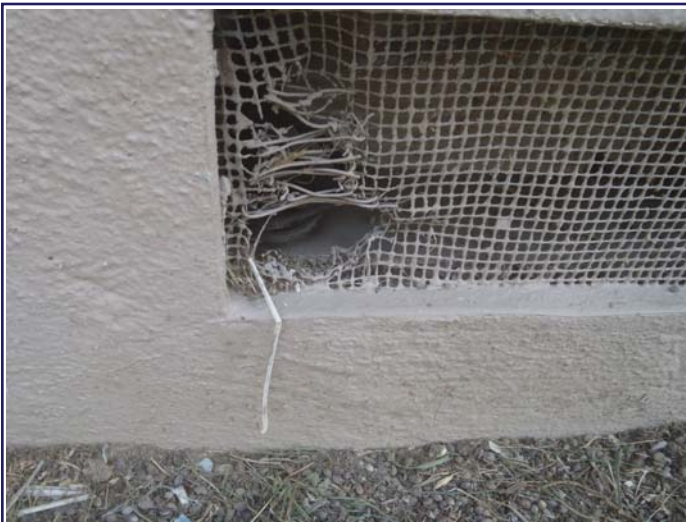
Photo 3

Broken foundation vent around the rear of the house

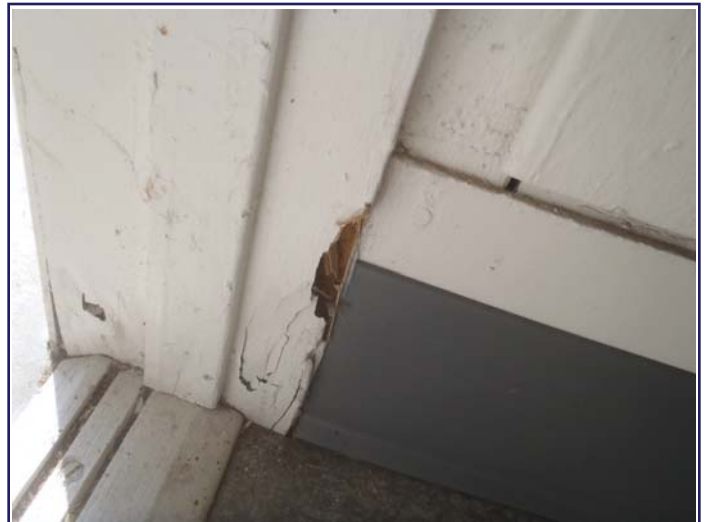
Photo 4

Damage to the bottom portion of the garage side door jamb/trim

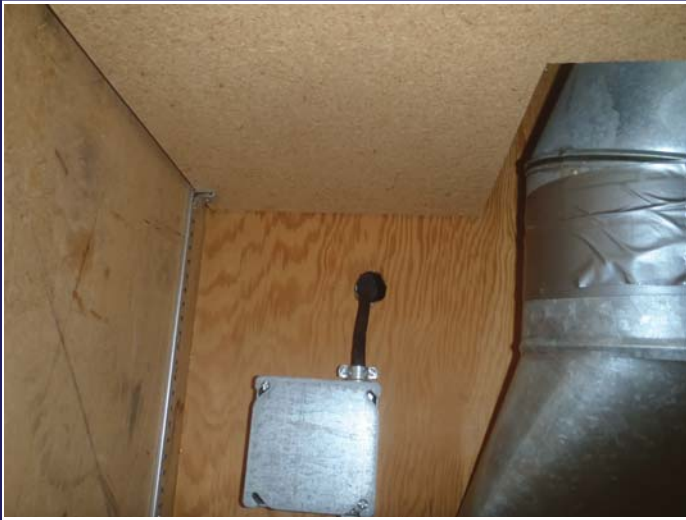
Photo 5

1) There was leakage observed from the sink's faucet (valve stem). It is recommended to repair or replace the faucet, for proper operation and to prevent possible water damage from occurring in this area. 2) There was unprotected electrical wiring observed in the cabinet above the stove. For safety, correction is recommended. All electrical wiring in habitable areas needs to be protectively covered or concealed in wall space, to prevent accidental contact or possible mechanical damage from occurring. 3) Some of the burners atop the stove did not respond when tested. For safety, correction is recommended. 4) There was a double P-trap below the sink area. If both sinks drain at the same time it may be possible that water from the second drain may block the vent when the first drain finishes and this could create a dry trap. Each fixture requires a separate trap (one trap per trap arm). Correction is recommended. 5) The garbage disposal and dishwasher unit are on a separate GFCI outlets, also the wall switch was installed behind the sink. This is a safety hazard. Correction is recommended. Consult with a licensed electrician for further evaluation and corrective repairs.

Unprotected electrical wiring in the kitchen cabinet above the stove

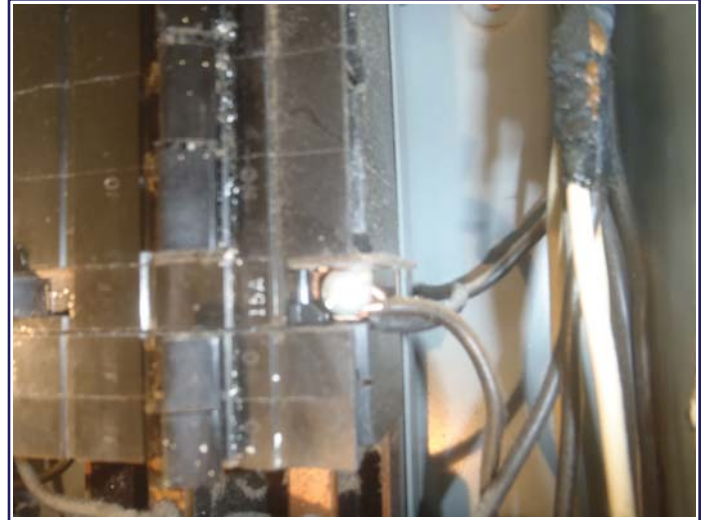
Photo 6

Double tapped 15 amp single pole circuit breaker in the sub panel

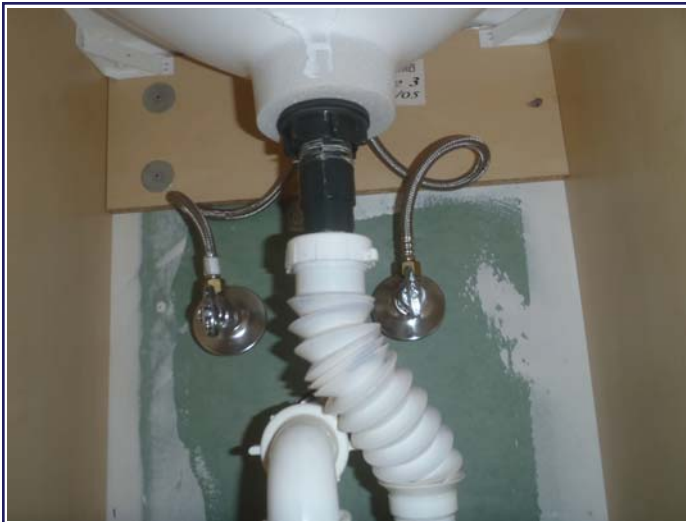
Photo 7

- 1) There is insufficient clearance between the hall bathroom sink and wall. Therefore, caution should be excersied in this area.
- 2) There is a flexible drain line installed below the sinks (tail piece connection), in the hall bathroom and half bathroom area. It is recommended to install a smooth wall drain line below the sink, to prevent possible debris from clogging the drain lines.
- 3) The sink in the hall bathroom drained slower than normal (P-trap may be clogged). It is recommended to have this corrected, for proper operation. Consult with a licensed plumber for corrective repairs.

Flexible drain line installed below the bathroom sinks

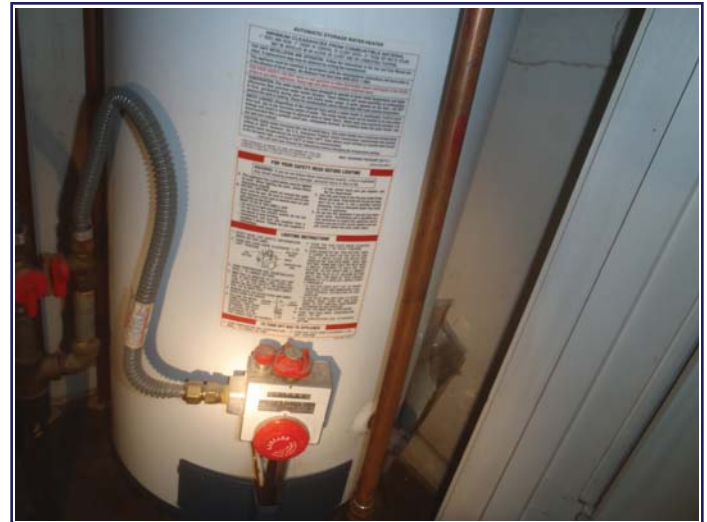
Photo 8

Water heater tank is not properly seismically strapped

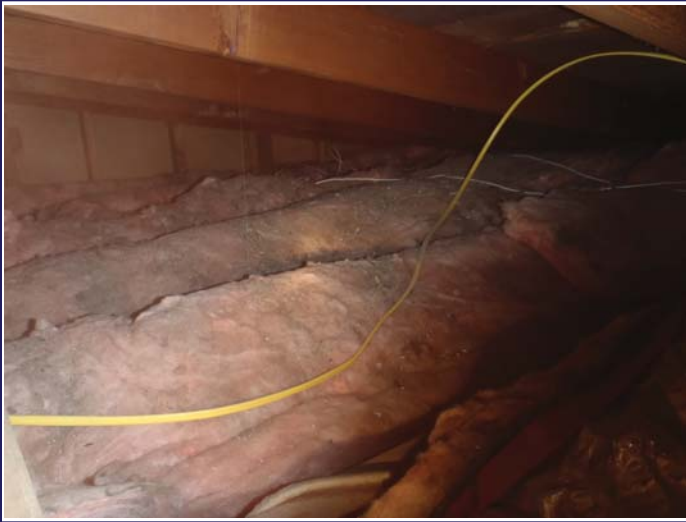
Photo 9

Loose electrical wiring in the attic area

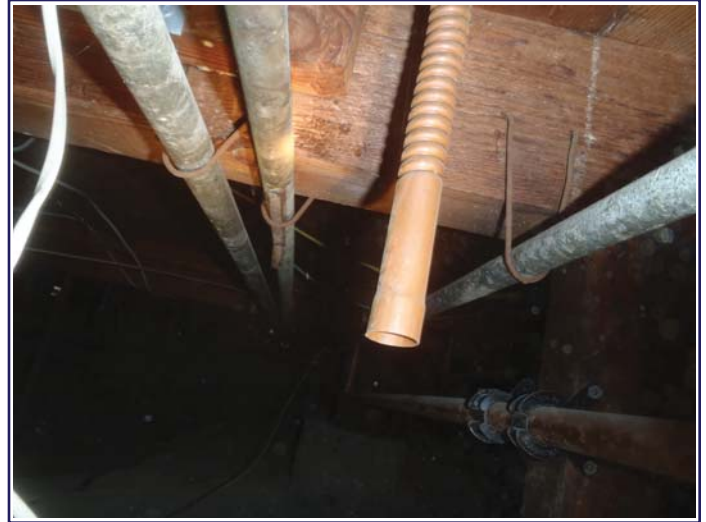
Photo 10

Discharge pipe for the water heater's TPR valve terminates in the sub area
