# WOOD DESTROYING PESTS AND ORGANISMS INSPECTION REPORT

BUILDING NO. <b>1481</b>	STREET, CITY, STATE, ZIP <b>Phanton Avenue, San Jose CA 95125</b>	Date of Inspection <b>3/9/2011</b>	No. of Pages <b>5</b>
  <div style="float: right; text-align: right;">                 305 Vineyard Town Center #326                  Morgan Hill, CA 95037-5674                  408-927-6300 or 650-322-5785                  FAX 408-997-0243                  Email officeadmin@tylertermite.com             </div>			
Firm Registration No. <b>PR 4359</b>	Report No. <b>18338</b>	Escrow No.	
Ordered By: Gillmor & Associates 1201 Franklin Mall Santa Clara, CA 95050 Attn: Lisa Gillmor	Property Owner/Party of Interest Medica 1481 Phanton Avenue San Jose, CA 95125  Gillmor & Associates 1201 Franklin Mall Santa Clara, CA 95050	Report Sent To: Gillmor & Associates 1201 Franklin Mall Santa Clara, CA 95050 Attn: Lisa Gillmor	
COMPLETE REPORT <input checked="" type="checkbox"/> LIMITED REPORT <input type="checkbox"/> SUPPLEMENTAL REPORT <input type="checkbox"/> REINSPECTION REPORT <input type="checkbox"/>

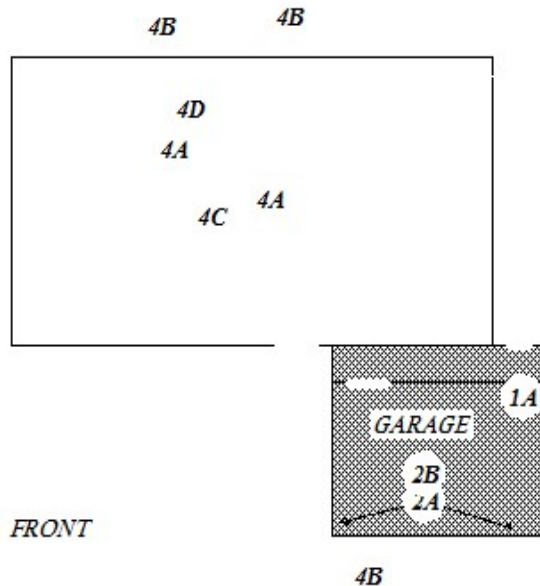
*DIAGRAM NOT TO SCALE*

ITEM 1A Subterranean termites were noted to be entering the substructure framing from the earth fill under garage slab floor at the area(s) indicated on diagram.

- ITEM 2A Evidence of drywood termites was noted at the area(s) indicated on the diagram (Garage interior wall framing). Infestation extends into inaccessible area(s).

- ITEM 2B Drywood termite pellets were noted at the areas as outlined in item 2A where indicated on the diagram.

- ITEM 4A Cellulose debris was noted in the subarea where indicated on the diagram.

- ITEM 4B Vent screen(s) were noted broken or missing where indicated on diagram.

RECOMMENDATION: Drill a series of holes through the garage slab floor, and pressure inject the soil below with TERMIDOR SC, a registered termiticide, in accordance with the manufacturers label. Seal the holes with mortar. Remove termite tubes as necessary.

RECOMMENDATION: Fumigate the entire structure with Vikane or Zythor gas and Cloropicrin for the complete eradication of drywood termite infestation. This company will furnish all necessary instructions for the owners or concerned parties prior to the fumigation date scheduled.

RECOMMENDATION: Remove and /or mask all accessible termite pellets.

RECOMMENDATION :Remove the cellulose debris of a rakable size from the subarea and dispose of.

RECOMMENDATION:Replace the broken or missing vent screens.
