TROY C. HARRISON
 Residential and Commercial Property Inspections
 A Member of the Real Estate Inspection Group, Inc.
 www.inspectiongroup.com

271 Serena Way

PROPERTY INSPECTION

Inspection Address: 271 Serena Way		Report Number:	
Inspection City: Santa Clara		Inspection Date: April 21, 2011	
Client Name: Penkse Automotive	<input type="checkbox"/>		
Agent's First Name: Lisa	Last: Gillmor	Phone: (408) 246-5020	Ext:
Office: Gillmor & Associates		Fax: (408) 246-5961	
Inspector: TROY C. HARRISON		www.TheReportOnline.com Report password: N/A

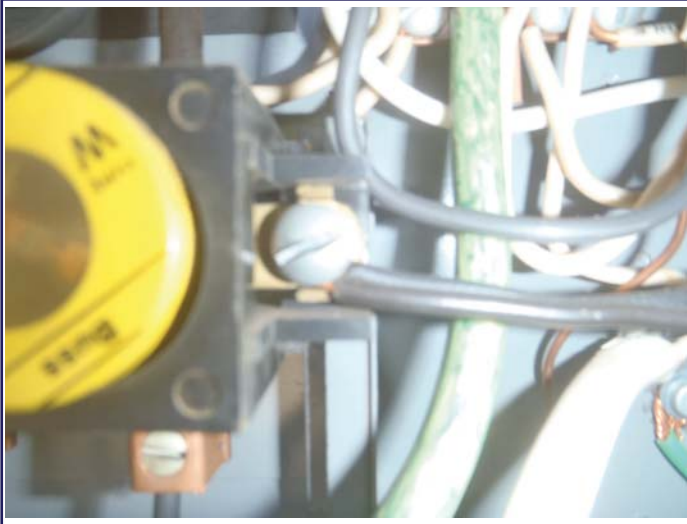
Photo 1

Double tapped 20 amp fuse in the main panel box

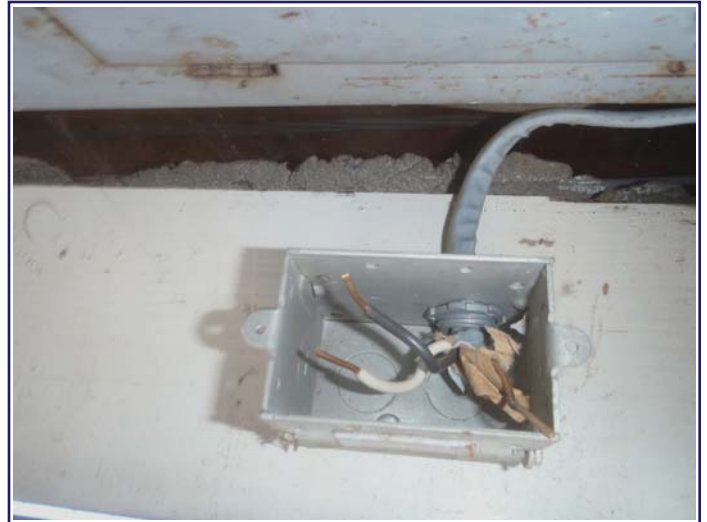
Photo 2

ELECTRICAL ACTION ITEMS: 1) There was an open junction-box inside the wooden cabinet for the main panel (hot wire). For safety, correction is recommended. 2) The circuit breakers in the main panel box were not completely labeled. Have the panel properly labeled upon occupying the house (all circuit breakers need to be clearly identified). 3) There was unprotected electrical wiring in the wooden cabinet box for the main panel, also unprotected electrical below the roof eaves around the left and right rear of the house. In addition, this type of wiring is not rated for exterior use. For safety, correction is recommended. All exterior electrical wiring which is within 10' feet from grade needs to be protectively covered, to prevent possible accidental contact or mechanical damage from occurring. 4) There were several uncovered J-boxes in the attic area, at various locations. I recommend installing a protective cover plate, for safety. 5) There was no visible ground wire (bonding jumper) to the water piping or gas line for the water heater tank. For safety, all interior metal piping which may be subject to being energized should be bonded. 6) There was unprotected electrical wiring in the garage area (may have been acceptable at the time of construction). For safe building practices, all electrical wiring in the garage area below 7' feet needs to be installed in rigid conduit or protectively covered to prevent accidental contact or mechanical damage from occurring. 7) There was exposed electrical wiring below the roof eaves on the right rear of the house, that does not terminate inside a junction box, For safety, correction is recommended. 8) The exterior junction boxes for the outside light, below the roof eaves front/rear are not weather proof type. Recommend correction, for safety. Continued on page 22

Exposed electrical wiring inside the wooden cabinet for the main panel

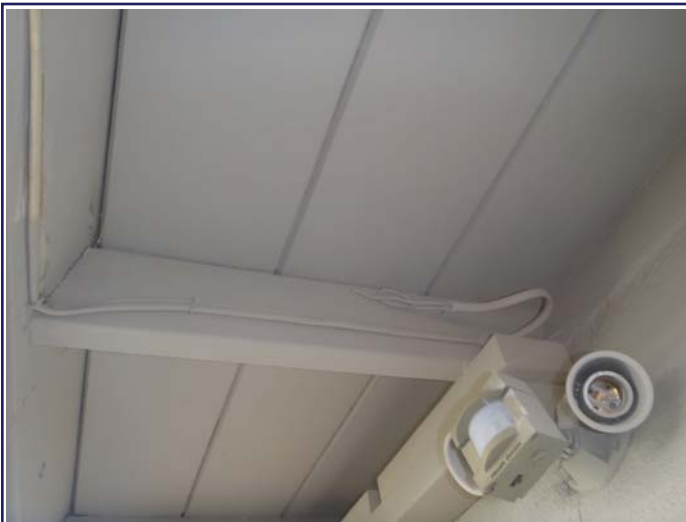
Photo 3

Unprotected electrical wiring below the roof eaves below the front rear of the house

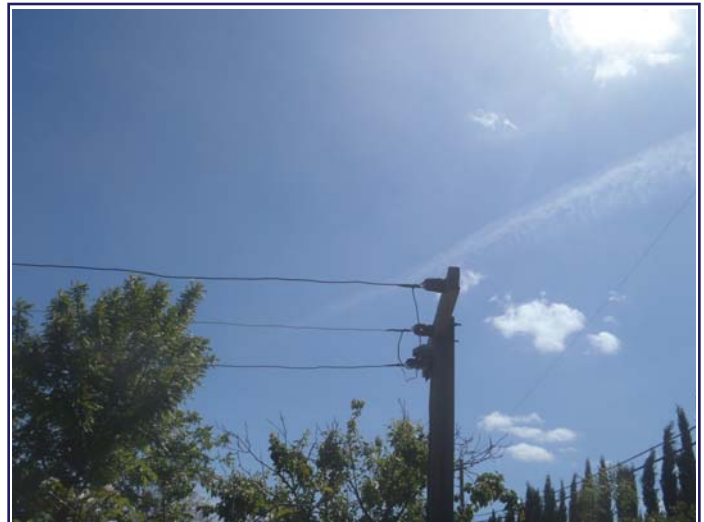
Photo 4

Overhead wiring in the rear yard is to low

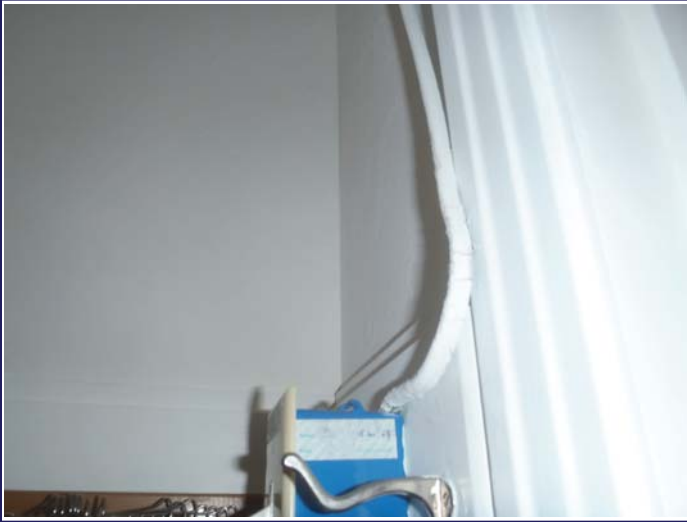
Photo 5

Unprotected electrical wiring in the rear bedroom closet

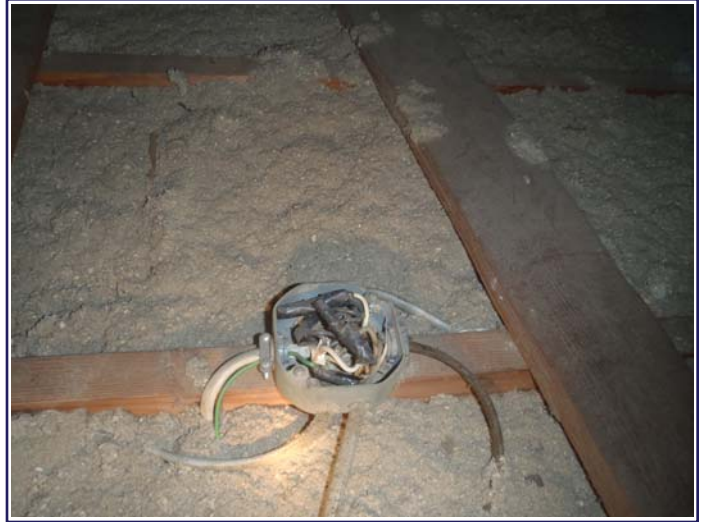
Photo 6

Uncovered junction boxes in the attic at several locations

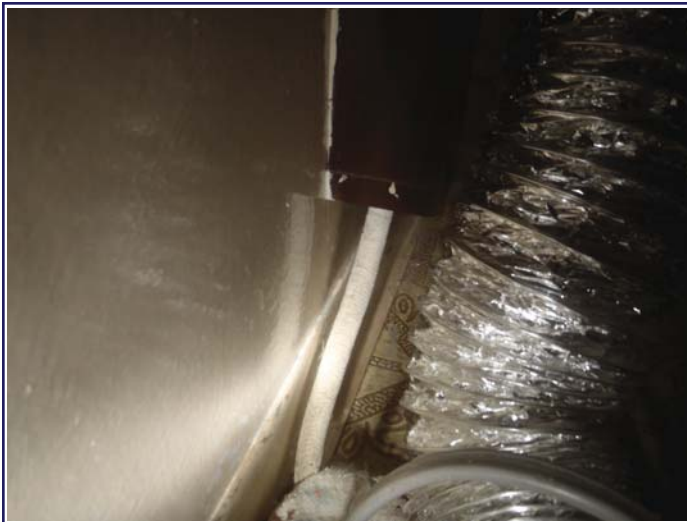
Photo 7

Unprotected electrical wiring in the laundry area

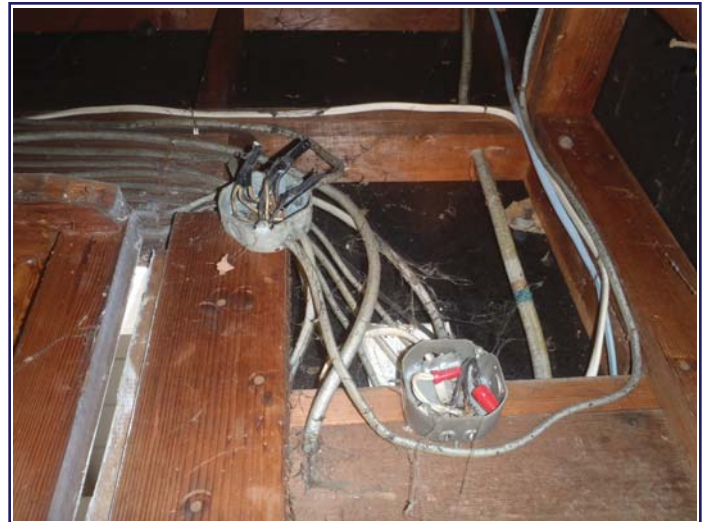
Photo 8

Uncovered junction boxes in the garage, adjacent to the door

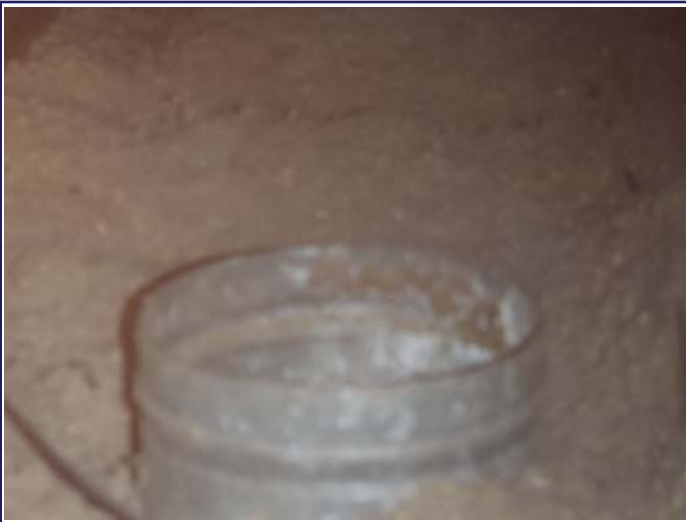
Photo 9

Missing exhaust duct above the kitchen area

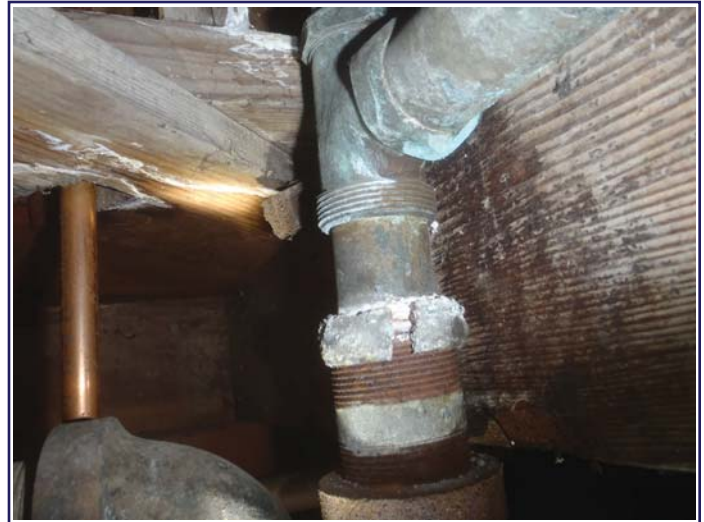
Photo 10

Broken slip-nut to the drain line below the hall bathtub
