# WOOD DESTROYING PESTS AND ORGANISMS INSPECTION REPORT

BUILDING NO. <b>271</b>	STREET, CITY, STATE, ZIP <b>Serene Way, Santa Clara CA 95051</b>	Date of Inspection <b>4/7/2011</b>	No. of Pages <b>5</b>
----------------------------	---	---------------------------------------	--------------------------

General Description: One story wood framed stucco/brick exterior, single family residence, brick with an attached two car garage.	Inspection Tag Posted: Garage
	Other Tags Posted: None noted

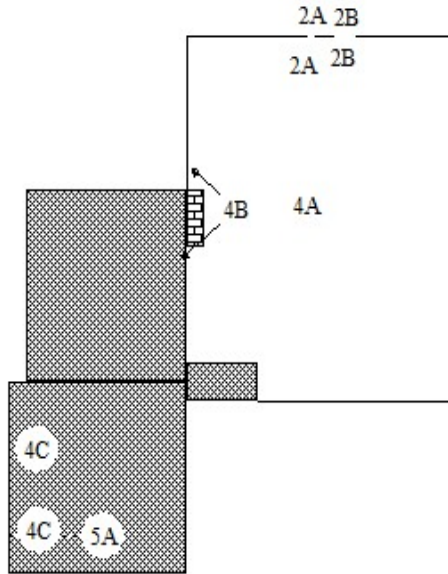
*DIAGRAM NOT TO SCALE*

ITEM 2A Evidence of drywood termites was noted at the area(s) indicated on the diagram (Interior and exterior window area). Infestation extends into inaccessible area(s).

ITEM 2B Drywood termite pellets were noted at the areas as outlined in item 2A where indicated on the diagram.

ITEM 4B Cellulose debris was noted in the subarea where indicated on the diagram.

ITEM 4C Waterstains were noted area where shown on diagram indicating possible leakage at the roof.

ITEM 5A The sheetrock at area indicated in the garage is waterstained and/or damaged.

RECOMMENDATION: Fumigate the entire structure with Vikane or Zythor gas and Cloropicrin for the complete eradication of drywood termite infestation. This company will furnish all necessary instructions for the owners or concerned parties prior to the fumigation date scheduled.

RECOMMENDATION: Remove and /or mask all accessible termite pellets.

RECOMMENDATION: Remove the cellulose debris of a rakable size from the subarea and dispose of.

RECOMMENDATION: The owner is to employ a licensed roofing contractor to inspect and repair the roof as found to be necessary.

RECOMMENDATION: Remove the stained and/or damaged sheetrock for further inspection. Issue a supplemental and cost estimate for any necessary repairs.
