**1660 Nobili Ave., 3351 Rayanna Ave.
Santa Clara CA 95051**

PROPERTY INSPECTION REPORT

Date: June 14, 2011

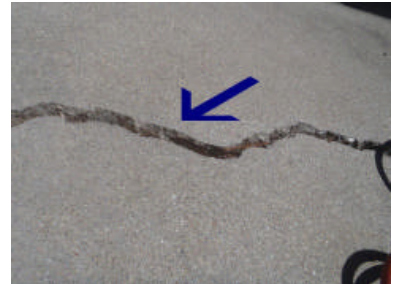
There were large cracks and heaving to a section of the rear detached concrete patio serving unit #3351. It is recommended to have this repaired, as this may create a potential tripping hazard. Consult with a qualified contractor for more extensive corrective recommendations and repairs.

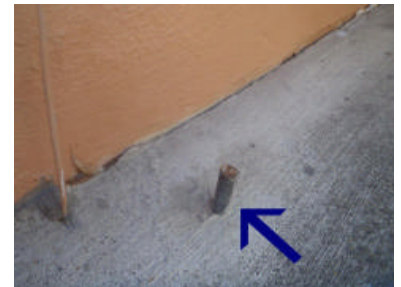
There was no visible grounding connection to the ground rod below the main panels.
Have a licensed electrician review the electrical system and perform repairs as needed.

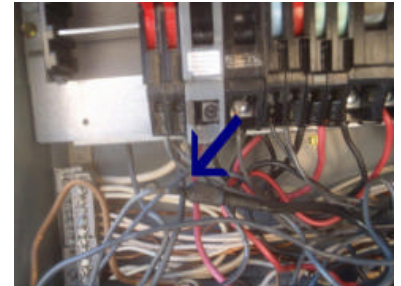
General condition appeared serviceable with the exception of the following: There was an open knock-out at the bottom of the main panel box. For safety, I recommend sealing the knock-out.

There was an unsafe wiring splice (evidence of overheating) to the 20 amp single pole circuit breaker in the panel. For safety, correction is recommended.

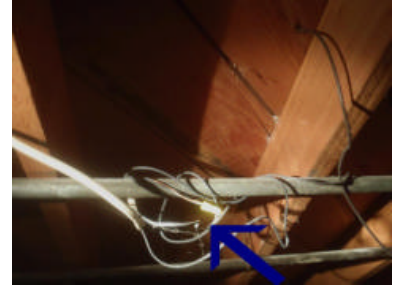
There was an unsafe electrical wiring method (running splice) observed in the sub area, located below the living room of unit #1660. I recommend having this corrected, for safety and to prevent possible mechanical damage from occurring. All splices need to take place in a junction box or listed fitting.

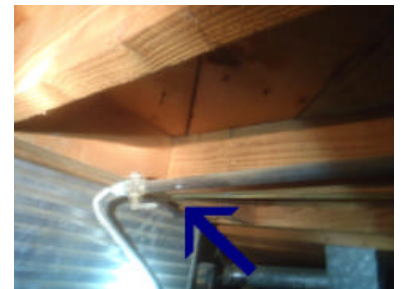
A section of the gas line in the sub area adjacent to the floor furnace below unit #3551 was not secured. Recommend correction, for safety.

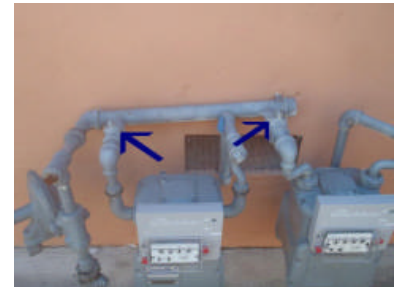
System appeared serviceable. However, we recommend installing an earthquake safety wrench at the gas meter, so in the event of an emergency the gas can be shut-off quickly.

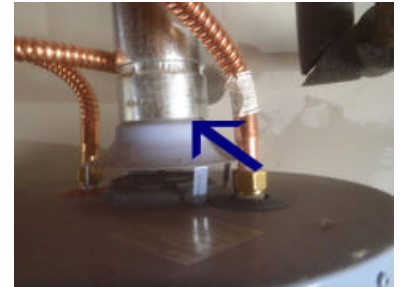
The flue pipe for the water heater was not properly fastened to the draft hood atop the unit. It is recommended to have this corrected. The flue pipe needs to have positive flow adequate of conveying the gases to the outside atmosphere.

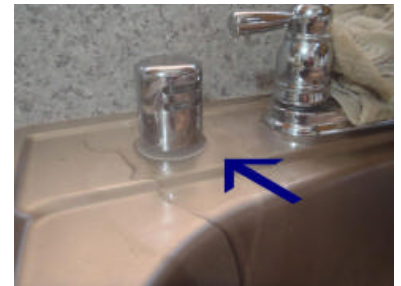
CONDITION:
Water discharged through the air gap valve while the dishwasher was in use. The line may be clogged or the disposal may be plugged, and this should be repaired to prevent possible back siphoning from occurring.

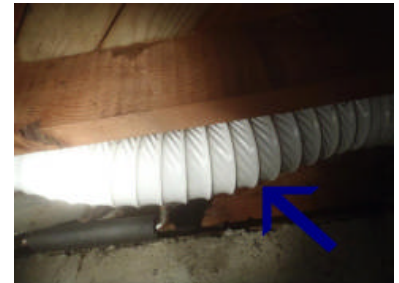
There was a flexible plastic exhaust duct installed in the sub area for the dryer's moisture exhaust duct. I recommend having this corrected, (per the manufactures recommendations this type of exhaust duct should not be installed in concealed locations.

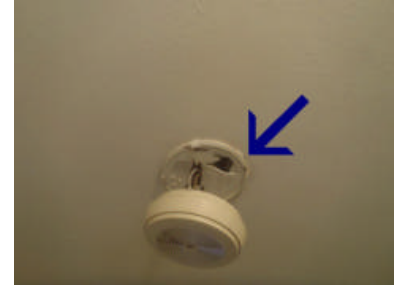
A smoke detector was located in the hallway areas of each unit. However, the smoke detector in the unit #3351 was not properly fastened at the ceiling. Correction is recommended, for safety. The smoke detectors were not tested, and should be checked before assuming occupancy. If the duplex has been remodeled or built new since Jan. 1986 (California Health & Safety Code 13111). There needs to be a detector in each sleeping room and at a point centrally located within the corridor.

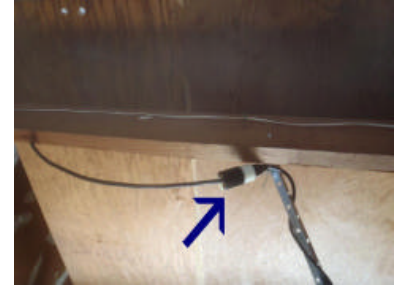
The garage doors for each unit were powered by extension cords. For safety, an outlet should be installed within reach of the factory cord, as extension cords should not be used in lieu of any permanent wiring methods. Correction is recommended.

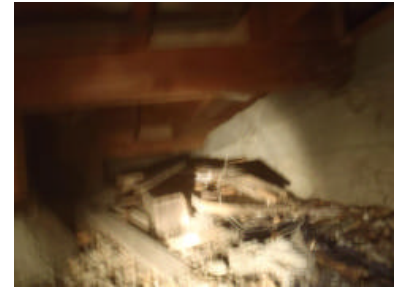
There is wood debris in the sub area below unit #3351. I recommend having the debris removed (See the structural pest control report for further recommendations and repairs).
