WOOD DESTROYING PESTS AND ORGANISMS INSPECTION REPORT

BUILDING NO. 678	STREET, CITY, STATE, ZIP San Miguel Avenue, Santa Clara CA 95050	Date of Inspection 6/14/2011	No. of Pages 6
----------------------------	--	--	--------------------------

General Description: One story wood framed stucco exterior, single family residence, vacant with an attached two car garage.	Inspection Tag Posted: Garage
	Other Tags Posted: Fumigation notice 2005 Inspection tag 2000

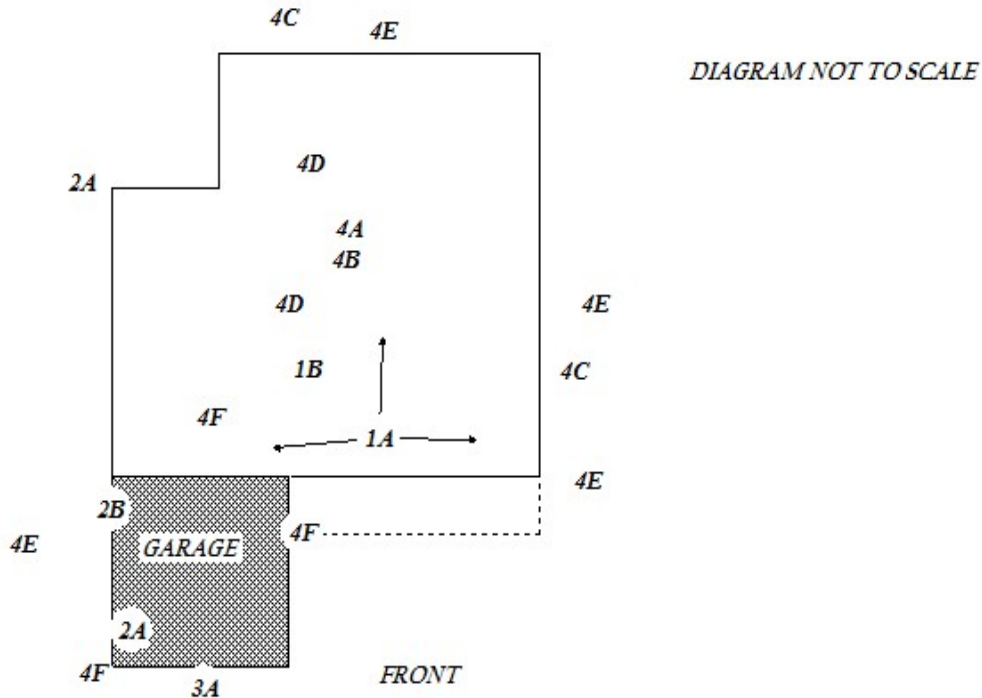
ITEM 1A Subterranean termites were noted to be entering the substructure framing from the earth fill under front porch at the area(s) indicated on diagram.

ITEM 2A Drywood termite pellets are evident at area(s) indicated on diagram. This structure is posted with a fumigation notice dated 2005.

ITEM 2B Drywood termite damage was noted at the stucco moulding where indicated on diagram.

ITEM 4C Vent screen(s) were noted broken or missing where indicated on diagram.

ITEM 4D Cellulose debris was noted in the subarea where indicated on the diagram.

ITEM 4E Hairline stress cracks or missing /broken stucco noted at areas where indicated on diagram.

ITEM 4F Waterstains were noted area where shown on diagram indicating possible leakage at the roof.

RECOMMENDATION: Drill a series of holes through the front porch, and pressure inject the soil below with TERMIDOR SC, a registered termiticide, in accordance with the manufacturers label. Seal the holes with mortar. Remove termite tubes as necessary.

RECOMMENDATION: Further inspection recommended. Remove or mask over these accessible pellets. Return in 30 days, make a further inspection and issue a Supplemental Report with findings and further recommendations. In the event that this infestation is found to be active, we would recommend, fumigation at additional cost.

RECOMMENDATION: Remove damage and replace with new material. Prime paint included on exterior repairs.

RECOMMENDATION:Replace the broken or missing vent screens.

RECOMMENDATION :Remove the cellulose debris of a rakable size from the subarea and dispose of.

RECOMMENDATION :Refinish or seal area(s) noted.

RECOMMENDATION: The owner is to employ a licensed roofing contractor to inspect and repair the roof as found to be necessary.
