PROPERTY INSPECTIONS

678 San Miguel Avenue
Santa Clara CA 95050

Prepared for: Standford & FlorencY Wittmayer
Prepared by: Troy C. Harrison - Inspector
PROPERTY INSPECTION REPORT

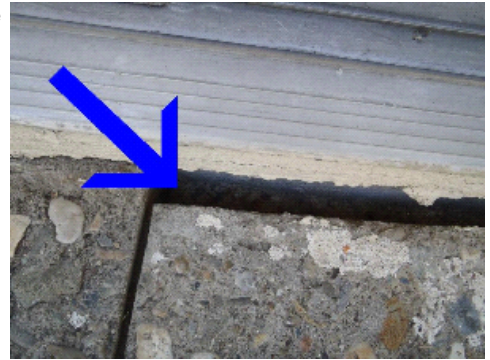
The general condition appeared serviceable at the time of inspection with the exception of the following: I recommend sealing the 1" inch +/- gap between the concrete patio and stucco wall, adjacent to the family room sliding glass door.

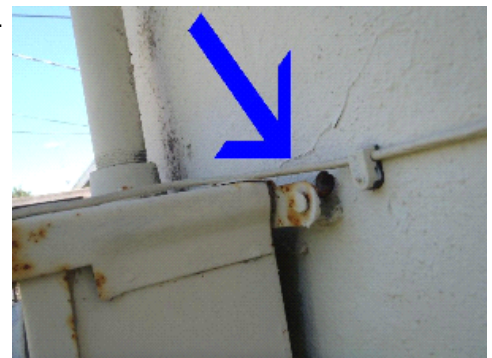
There were bushes obstructing the front of the main panel box, there should be at 36" inches of clearance to the front of the panel. Recommend trim back the bushes.

The panel cabinet/box was not properly fastened to the exterior stucco wall. Correction is recommended, for safety.

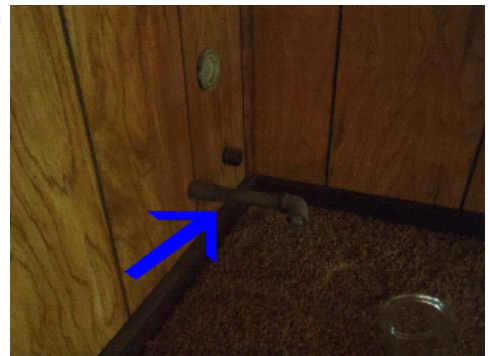
There is an old gas line that sticks-out of the wall (approx. 8"-10" inches) in the family room, behind the half bath (may be for a prior free standing heater). Recommend having this corrected, for safety.

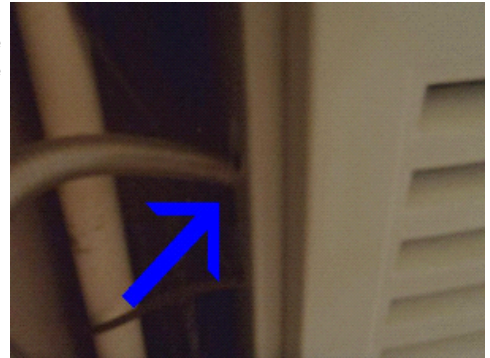
The flexible gas line penetrated through the furnace's cabinet wall. An upgrade would be to install a rigid metal pipe to the control valve. If the gas line inadvertently is in contact with the metal housing and there is vibration to the unit this may cause damage to the flexline.

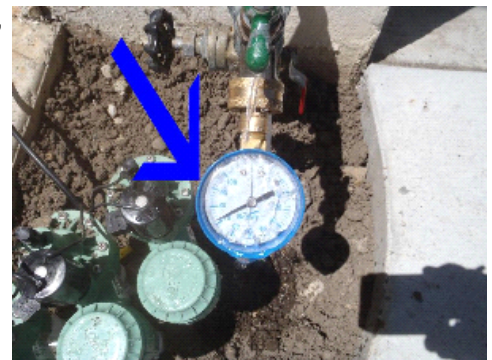
Appeared serviceable. The water pressure tested at approximately 70 PSI, which is considered normal (adequate and safe) water pressure.

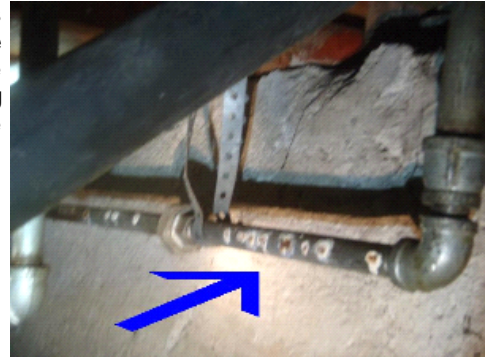
Water was run through the pipes to test for functional flow and the piping was inspected where visible. General condition appeared serviceable with the exception of the following: There was corrosion observed to a section of the galvanized piping below the laundry room area. Older galvanized plumbing tends to rust from the inside causing the internal bore to be reduced over time and will likely need to be replaced in the future. Recommend further evaluation by a licensed plumber and to perform repairs as needed.

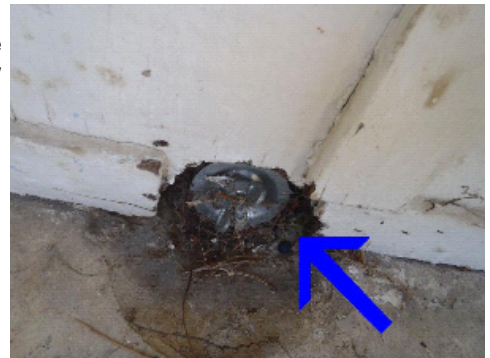
Water was run through the drain piping to test functional flow and the piping was inspected where visible. General condition appeared serviceable with the exception of the following: There is a temporary plug for the clean-out below the kitchen window area. Recommend correction.

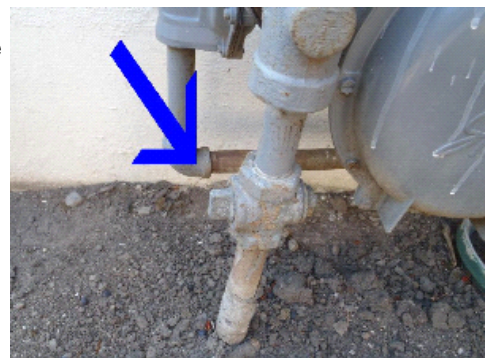
General condition appeared serviceable with the exception of the following: System appeared serviceable. However, I recommend installing an earthquake safety wrench at the gas meter, so in the event of an emergency the gas can be shut-off quickly.

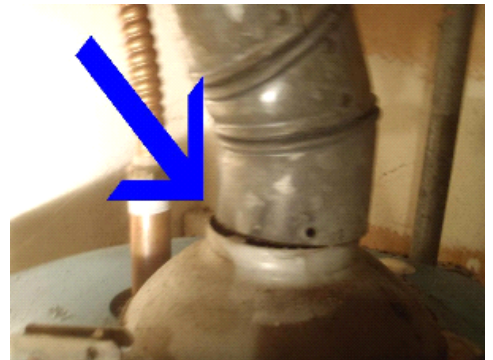
The general condition appeared serviceable with the exception of the following:
The flue pipe for the water heater was not properly fastened to the draft hood atop the unit. Correction is recommended.

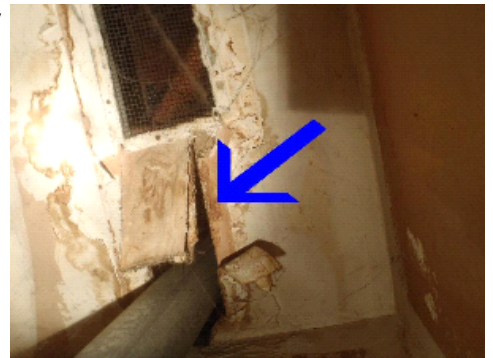
There was water damage to the sheetrock ceiling above the water heater (may be from an prior roof leak). Recommend correction.

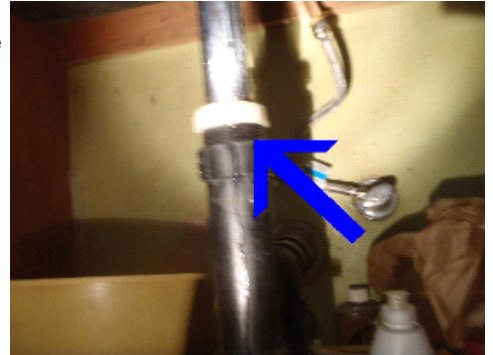
There was leakage observed from the drain line (tail piece/P-trap connection) below the kitchen sink area. Correction recommended, to prevent possible damage from occurring.
