WOOD DESTROYING PESTS AND ORGANISMS INSPECTION REPORT

BUILDING NO. 258	STREET, CITY, STATE, ZIP Rodonovan Drive, Santa Clara CA 95051	Date of Inspection 8/8/2011	No. of Pages 6
----------------------------	--	---------------------------------------	--------------------------

General Description: One story wood framed stucco/brick/wood exterior, single family residence, vacant with an attached two car garage.	Inspection Tag Posted: Garage Other Tags Posted: Terminix 1995 / Able 1977
--	---

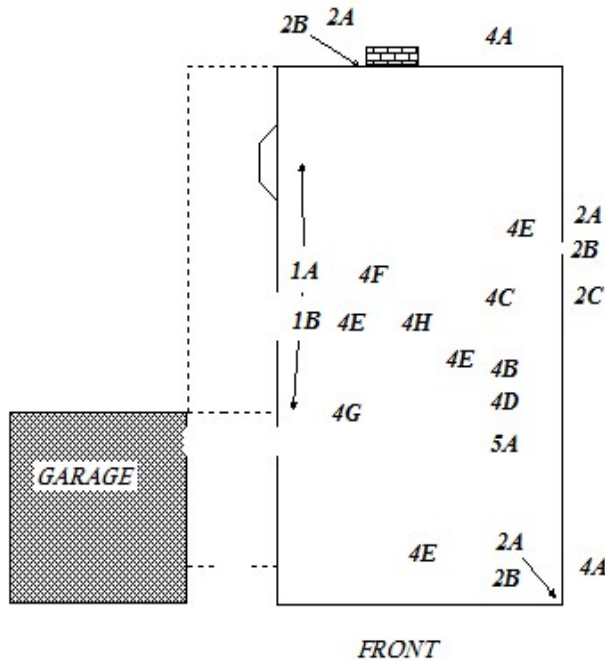
DIAGRAM NOT TO SCALE

ITEM 1A Inactive evidence of Subterranean termites were noted at area(s) indicated on diagram. Previous chemical treatment have been performed in this area.

ITEM 1B Minor Subterranean termite damage was noted at the rim joist where indicated on diagram.

- ITEM 2A Evidence of drywood termites was noted at the area(s) indicated on the diagram (Roof eaves, subarea and related framing). Infestation extends into inaccessible area(s).

- ITEM 2B Drywood termite pellets were noted at the areas as outlined in item 2A where indicated on the diagram.

- ITEM 4A Vent screen(s) were noted broken or missing where indicated on diagram.

ITEM 4E Cellulose debris was noted in the subarea where indicated on the diagram.

ITEM 4G Waterstains were noted area where shown on diagram indicating possible leakage at the roof.(Water heater closet ceiling)

RECOMMENDATION : Remove old evidence.

RECOMMENDATION: Reinforce with new material.

RECOMMENDATION: Fumigate the entire structure with Vikane or Zythor gas and Cloropicrin for the complete eradication of drywood termite infestation. This company will furnish all necessary instructions for the owners or concerned parties prior to the fumigation date scheduled.

RECOMMENDATION: Remove and /or mask all accessible termite pellets.

RECOMMENDATION: Replace the broken or missing vent screens.

RECOMMENDATION :Remove the cellulose debris of a rakable size from the subarea and dispose of.

RECOMMENDATION: The owner is to employ a licensed roofing contractor to inspect and repair the roof as found to be necessary.
