PROPERTY INSPECTIONS

475 Saratoga Avenue
Santa Clara CA 95050
Prepared for: Rena Salomon
Prepared by: Troy C. Harrison - Inspector
PROPERTY INSPECTION REPORT

0003291.

08/31/2011 01:30 PM.

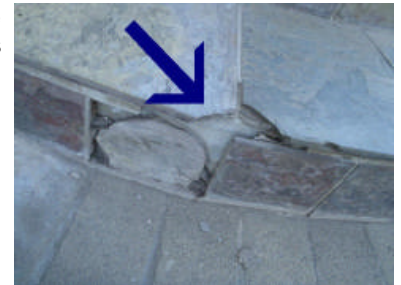
CONDITION:
General condition appeared serviceable with the exception of the following: There were some chipped and loose face tiles to the step/landing. For safety, correction is recommended.

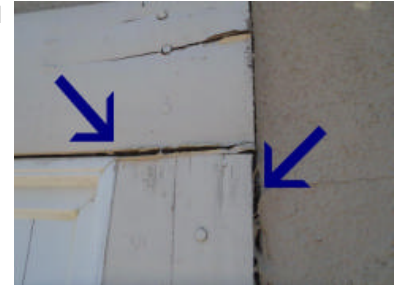
There were gaps observed at the joints to the trim and between the stucco wall around the exterior doors/windows at the rear of the house. Recommend correction to prevent possible moisture intrusion.

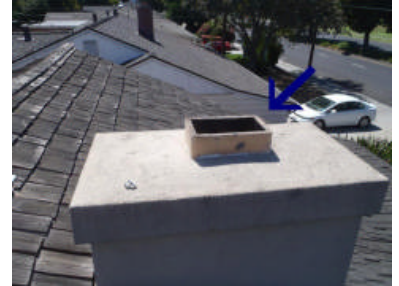
CONDITION:
No spark screen or weather cap was present. This is a fire/safety hazard. We recommend installing a listed spark arrester/cap to all chimneys that burn solid fuel.

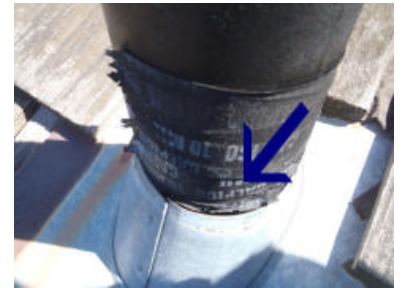
We recommend re-sealing the plumbing vents which penetrate the roof jacks, to prevent possible moisture intrusion.

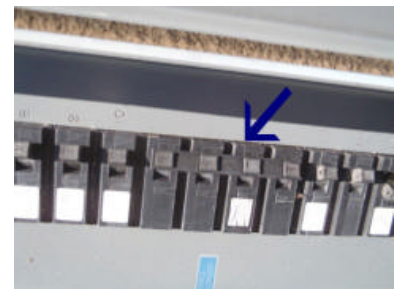
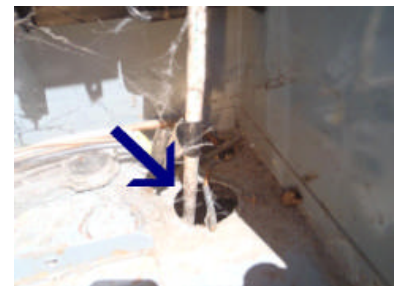
General condition appeared serviceable with the exception of the following: There was a missing bushing for the knock-out opening in the panel. For safety, correction is recommended.

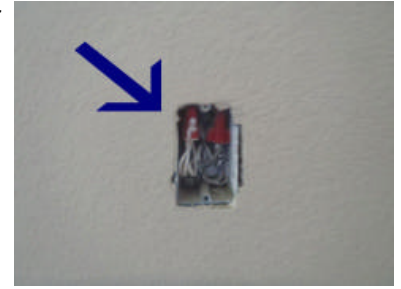
There was an uncovered junction box in the rear bedroom adjacent to the exterior french doors. We recommend installing a protective cover plate, for safety. All electrical wiring in habitable areas needs to be protectively covered or concealed in wall space, to prevent accidental contact or mechanical damage from occurring.

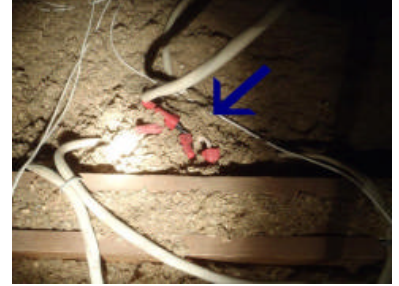
There was an unsafe electrical wiring method (running splice) observed in the attic area, located above the living room. Correction is recommended, for safety and to prevent possible mechanical damage from occurring. All splices need to take place in a junction box or listed fitting.

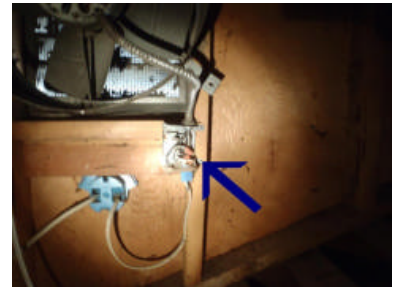
There was uncovered junction box in the attic, below the gable end fan. We recommend installing protective cover plates, for safety.

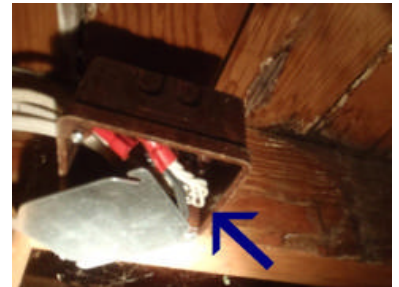
There was an uncovered junction box in the sub area, located below kitchen area. Correction is recommended, for safety

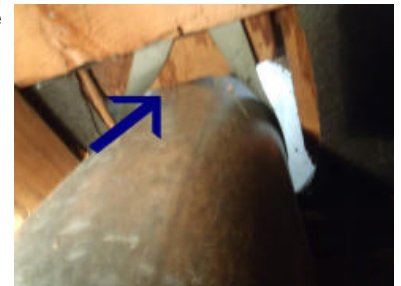
The furnaces flue pipe was in contact with the roof sheathing in the attic. We recommend having this corrected, for safety. There needs to be at least 1" inch of annular space between the double wall flue pipe and any combustible materials.

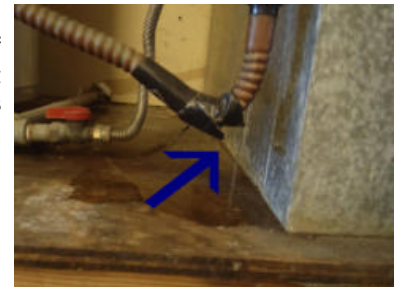
The condensing drain line from the evaporator is leaking and is not properly installed. Condensate overflow discharge pipes need to be installed to terminate to the exterior of the house or to an approved plumbing fixture. In addition, there was no visible trap/vent installed for the condensate line. The trap when filled with water, prevents air and odors from being drawn back into the evaporator compartment. Correction is recommended.

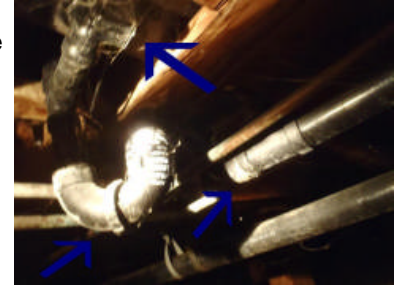
There was leakage from the drain line below the master bathroom tub/shower area. In addition, a section of the piping was cracked and the slip-nut was not fastened to the trap. Recommend correction, to prevent possible damage from occurring.

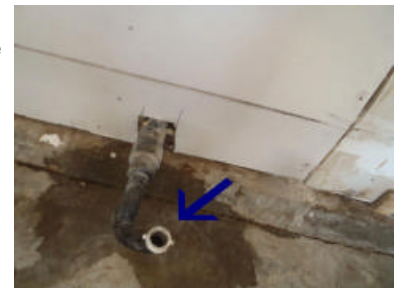
There was an open plumbing drain line in the garage (for old wash basin sink). We recommend having this repaired or removed if no longer in use, to prevent possible back flow of gases from the vent system and entering habitable space.

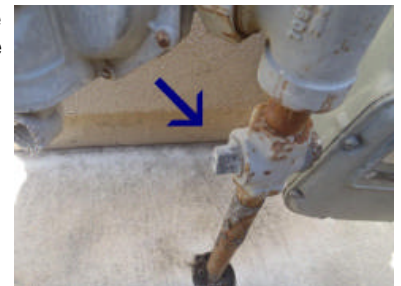
System appeared serviceable. However, we recommend installing an earthquake safety wrench at the gas meter, so in the event of an emergency the gas can be shut-off quickly.

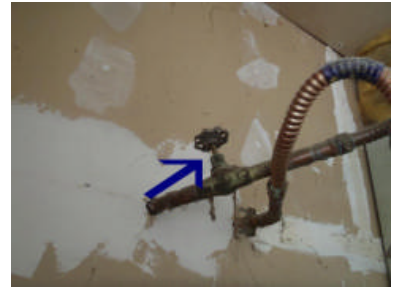
The general condition appeared serviceable with the exception of the following: The shut-off valve atop the water heater is frozen. Recommend correction for proper operation and in the event of an emergency the water needs to be turned off.

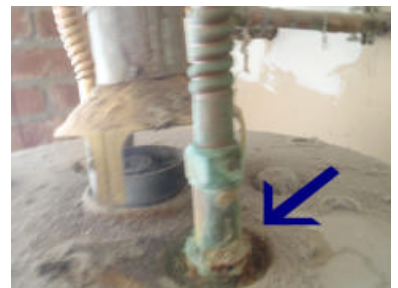
There was leakage noted atop the water heater (fitting connection). Correction is recommended.

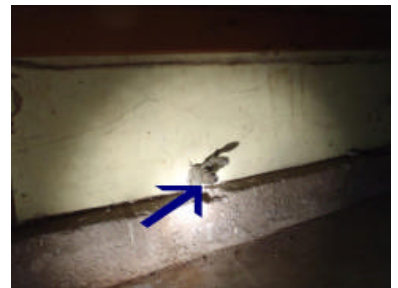
There is an uncapped gas valve below the water heater platform. This is a fire hazard. For safety, we recommend having the valve properly capped or removed.

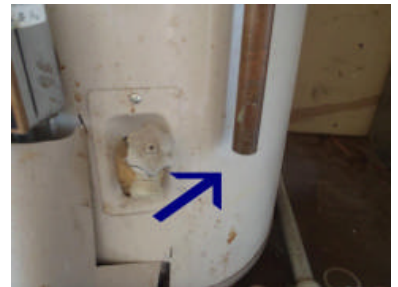
The flexible gas connector and shut-valve are installed below the tank in front of the burner opening. For safety, correction is recommended.

The discharge pipe for the water heaters temperature pressure relief valve was not properly installed. For safe plumbing practices, correction is recommended. The discharge pipe needs to be installed to drain by gravity flow and terminate atmospherically to the exterior of the house 6" above grade or to an indirect waste receptor and the end of the pipe should not be threaded.

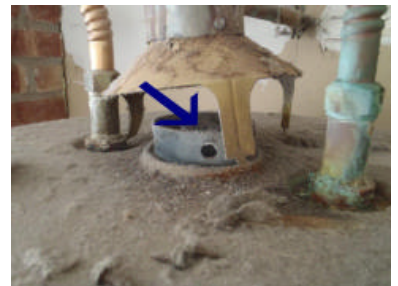
The draft hood for the water heater was not properly fastened atop the unit. Correction is recommended. Draft hoods provide additional air for the combustion process of gases. If not properly installed noxious gases may be expelled into habitable space.

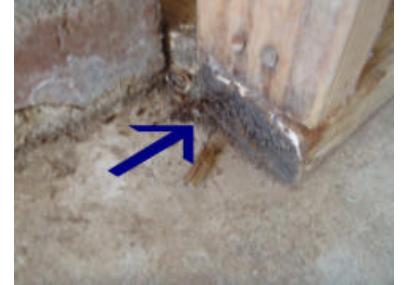
There was damage to the 2"x4" plate below the water heater. Correction is recommended (See the structural pest control report for further recommendations and repairs).

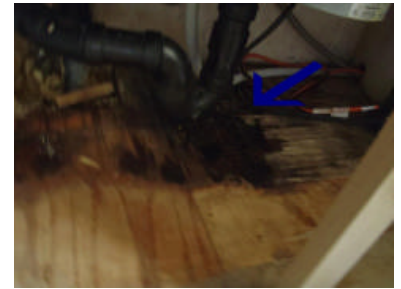
There was water damage to the wooden cabinet/shelf below the sink area. Correction is recommended (See the structural pest control report for further recommendations and repairs).

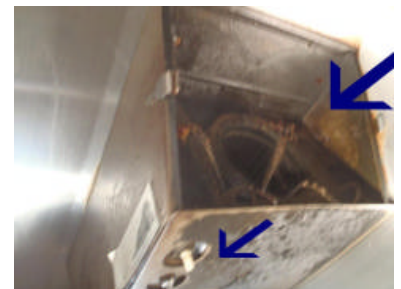
Ducted fan, functioned properly when tested. However, the control knobs are missing, also the cover for the fan is missing below the exhaust hood. For safety, correction is recommended.

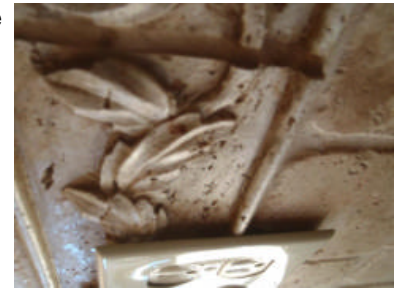
There were gaps noted between the cover plate for the wall outlets above the counter-top. An upgrade (for safety) would be to have this corrected.

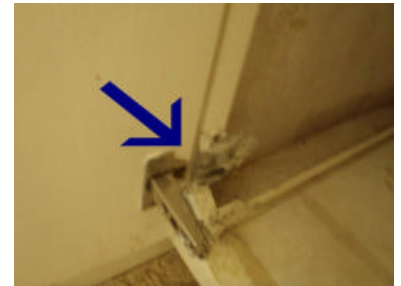
There was damage observed to the cabinet shelf below the sink area (front left). Correction is recommended (See the structural pest control report for further recommendations and corrective repairs).

The bottom hinge for the cabinet door (front left side) is disconnected. Recommend correction for proper operation and safety.

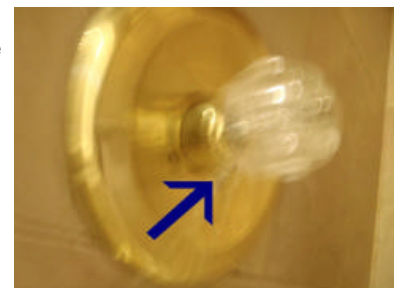
There was leakage observed from the faucet (valve stem). We recommend repairing or replacing the faucet, for proper operation and to prevent possible water damage from occurring in this area.

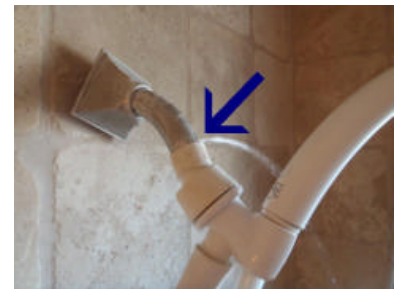
There was leakage from the shower head/arm connection in the tub/shower enclosure. Correction is recommended, to prevent possible damage from occurring.

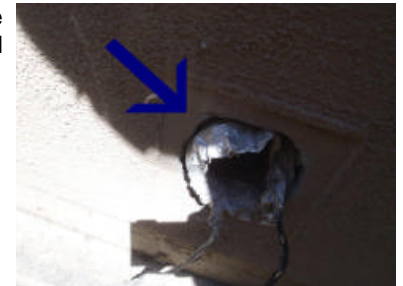
There is damage and a missing baffle for the dryer exhaust duct on the right rear of the garage. We recommend repair or replacement for safety and to prevent unwanted pests from entering the duct.

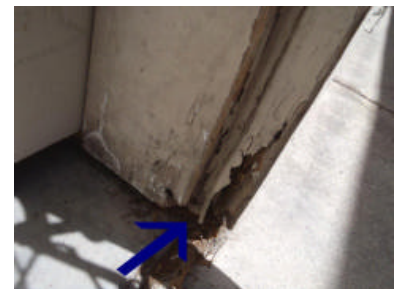
There was damage to the garage side door jamb (See the structural pest control report for further information and repairs).

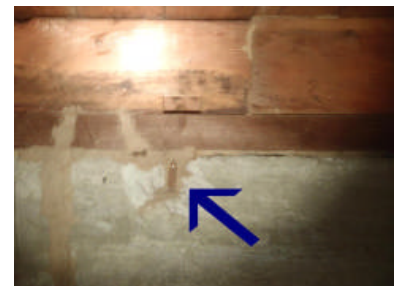
There is was one exposed anchor bolt to the interior face of the concrete stemwall below the front left of the house. Correction is recommended.

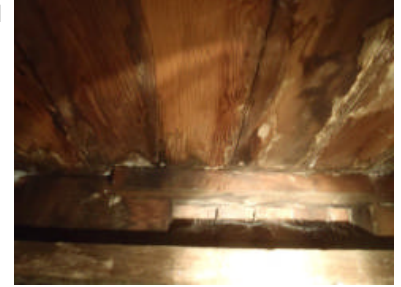
Minimal ventilation was viewed in the crawlspace below the rear of the home. This condition has caused moisture build up and damage to some of the floor framing members and corrosion to some of the GH hangers. We recommend correction and the installation of additional vents in this area for proper ventilation. There should be a net area not less than 1square foot for each 150 square feet of underfloor area. Consult with the appropriate licensed contractor for further evaluation and

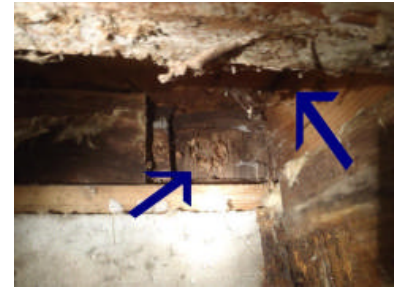
Tongue and Groove (original portion of house). There were old moisture stains and surface fungus observed to a section of the sub floor below the bathrooms and kitchen area (See the structural pest control report for further recommendations and repairs).

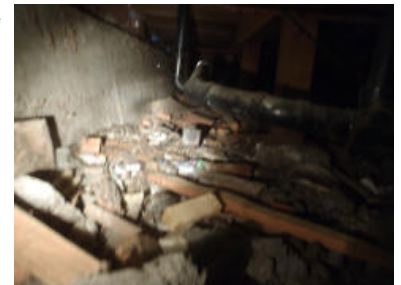
There was debris in the sub area, at various locations. We recommend having the debris removed (See the structural pest report for further information and repairs).

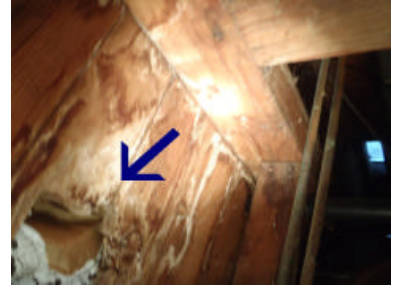
There were old moisture stains and a hole to a section of the sub floor below the kitchen area. Correction is recommended, to prevent any unwanted pest from entering this area and possibly causing damage.
