WOOD DESTROYING PESTS AND ORGANISMS INSPECTION REPORT

BUILDING NO. 475	STREET, CITY, STATE, ZIP Saratoga Avenue, Santa Clara CA 95050	Date of Inspection 8/29/2011	No. of Pages 7
----------------------------	--	--	--------------------------

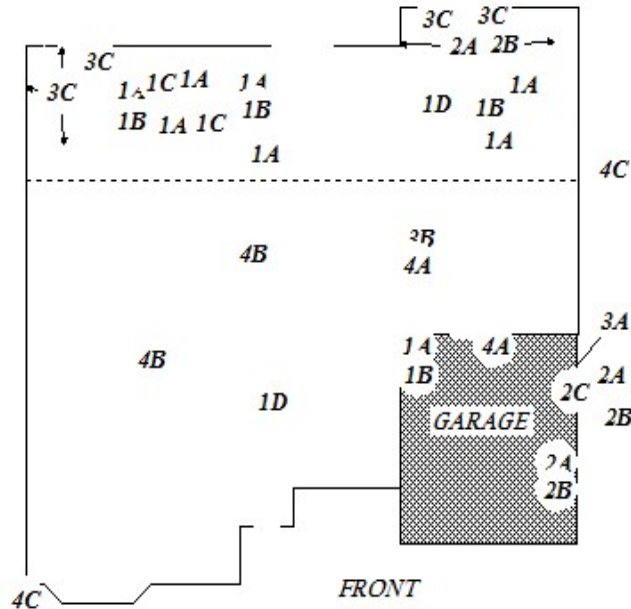
DIAGRAM NOT TO SCALE

ITEM 1A Subterranean termite infestation was noted at the area(s) indicated on the diagram.

ITEM 1B Subterranean termite tubes were noted at the areas indicated on diagram.

ITEM 1C Subterranean termite damage was noted at the floor joist where indicated on diagram.

ITEM 2A Evidence of drywood termites was noted at the area(s) indicated on the diagram (Subarea, garage and exterior). Infestation extends into inaccessible area(s).

ITEM 2B Drywood termite pellets were noted at the areas as outlined in item 2A where indicated on the diagram.

ITEM 2C Drywood termite damage was noted at the exterior door jambs where indicated on diagram.

ITEM 3A Fungus damage was noted at the recessed 1x4 door trim where indicated on diagram.

ITEM 3C Extensive fungus,Subterranean termite and Drywood termite damage was noted at the rim joists, floor joists and plywood subfloor where indicated on diagram. It appears that lack of proper ventilation has contributed to this condition.

ITEM 4C Hairline stress cracks or missing /broken stucco noted at areas where indicated on diagram.

RECOMMENDATION: Perform a complete perimeter soil treatment at the interior and exterior bases of foundation walls using TERMIDOR SC. Drill concrete patios, porches and walkways every 18-20 inches and treat soil beneath. Reseal all drilled areas with concrete. Treat soil at all concrete piers and treat all plumbing lines in direct soil contact. Remove and dispose of small to rakable sized cellulose debris. Stored lumber, large amounts wood debris or cardboard will be removed from the subarea but owners are to dispose of. Plants at the exterior may get damaged during treatment, we assume no liability for damaged plants.

RECOMMENDATION: Destroy all accessible termite tubes.

RECOMMENDATION: Reinforce damaged joists by sistering with new material.

RECOMMENDATION: Fumigate the entire structure with Vikane or Zythor gas and Cloropicrin for the complete eradication of drywood termite infestation. This company will furnish all necessary instructions for the owners or concerned parties prior to the fumigation date scheduled.

RECOMMENDATION: Remove and /or mask all accessible termite pellets.

RECOMMENDATION: Remove damage and replace with new material. Prime paint included on exterior repairs.

RECOMMENDATION: Remove carpeting,plywood subfloor/ insulation and at areas noted for further inspection of areas and to determine the extent of the damage. issue a supplemental report and cost estimate for all necessary repairs. Concerned parties to contact a property inspection company or foundation contractor for more information regarding ventilation issue.

RECOMMENDATION :Refinish or seal area(s) noted.
