TROY HARRISON

PROPERTY INSPECTIONS

1389 Taka Court
San Jose CA 95122
Prepared for: Nancy Faria
Prepared by: Troy C. Harrison - Inspector
PROPERTY INSPECTION REPORT

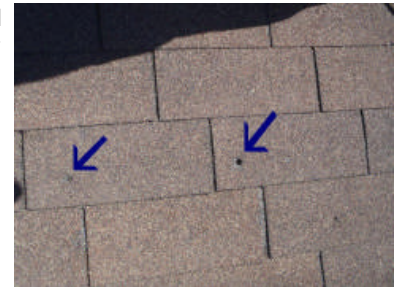
The roof covering overall appears in good condition. However, there were exposed roofing nails observed above the garage area. Have a licensed roofing contractor re-inspect the roof covering, and perform routine maintenance and repairs as needed.

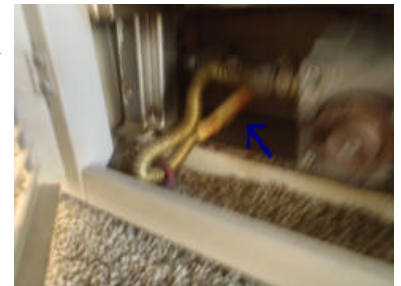
The wall heater has a flexible brass type gas connector (was acceptable practise at the time of installation). These type of gas lines have been known to deteriorate and leak over time and are no longer used. We recommend upgrading the gas line connector, for safety enhancement.

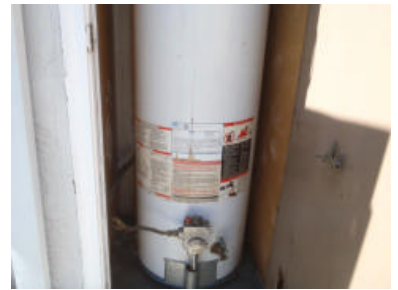
The water heater was not seismically strapped. In seismic zones 3 and 4, water heater tanks need to be anchored or strapped to resist horizontal displacement in the event of seismic activity. Correction is recommended. Sellers are required to strap water heaters to current industry standards as of 1/1/96 (California Health & Safety Code 19211). The standard calls for 16 ga. straps, one within 9" of the top, and the second within 4" of where the gas service enters the water heater. Each strap must be secured with 3" X 1/4" lag bolts.

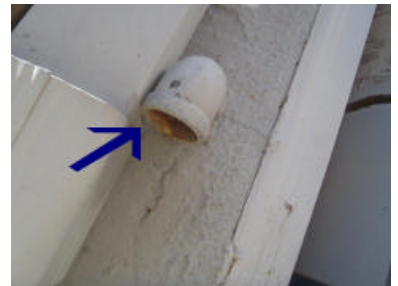
The discharge pipe for the water heaters temperature pressure relief valve was not properly installed (has a threaded pipe end).The discharge pipe should be installed to drain by gravity flow and terminate atmospherically to the exterior of the house 6" above grade or to an indirect waste receptor and the end of the pipe should not be threaded.

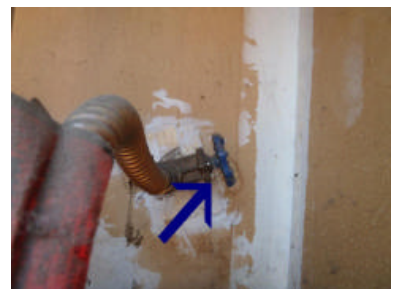
The shut-off valve atop the water heater tank is frozen. Recommend correction for proper operation and in the event of an emergency the water needs to be turned off.

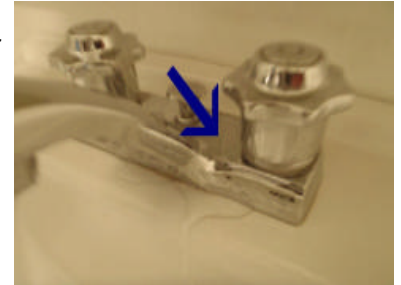
There was leakage observed from the sink's faucet (valve stem). We recommend repairing or replacing the faucet, for proper operation and to prevent possible water damage from occurring in this area.

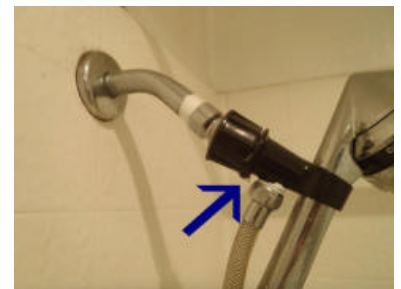
There was leakage from the shower head/arm connection. Correction is recommended, to prevent possible damage from occurring.
