WOOD DESTROYING PESTS AND ORGANISMS INSPECTION REPORT

BUILDING NO. 1389	STREET, CITY, STATE, ZIP Taka Court, San Jose CA 95122	Date of Inspection 8/29/2011	No. of Pages 5
-----------------------------	--	--	--------------------------

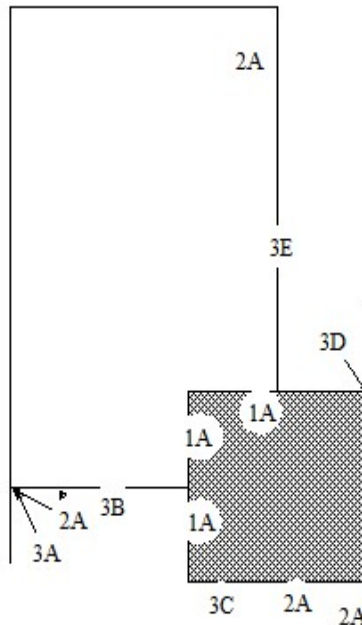
ITEM 1A Subterranean termites were noted to be entering the substructure framing from the earth fill under garage slab floor at the area(s) indicated on diagram.

ITEM 2A Drywood termite infestation was noted at the area(s) indicated on the diagram (Interior wall and exterior walls behind siding and stucco). Primary recommendation is to fumigate the entire structure with Vikane gas and Chloropicrin for the eradication of said infestation. As requested by the concerned parties, we offer the following secondary recommendation.

ITEM 3A Fungus Drywood Subterranean termite damage was noted at the 2x8 and 2x2 fascia/trim where indicated on diagram.

ITEM 3B Fungus and Drywood termite damage was noted at the plywood panel and trim where indicated on diagram.

ITEM 3D Fungus damage was noted at the 2x10 fascia where indicated on diagram.

RECOMMENDATION: Drill a series of holes through the garage slab floor, and pressure inject the soil below with TERMIDOR SC, a registered termiticide, in accordance with the manufacturers label. Seal the holes with mortar. Remove termite tubes as necessary.

RECOMMENDATION: Locally treat the infested area(s) by drilling and injecting INVADER HPX-20 into the infested framing for the eradication of drywood and apply Timbor (Disodium Octaborate Tetrahydrate) to exposed framing, termites. Remove termite evidence. If sheetrock, stucco or wood siding and trim needs to be removed to perform this treatment, our estimate will include replacing material at area noted. Paint included on exterior only.

RECOMMENDATION: Remove damage and replace with new material. Prime paint included on exterior repairs.
