TROY HARRISON

PROPERTY INSPECTIONS

2925 Hidalgo Ct.
San Jose CA 95125
Prepared for: Kathleen McDonald
Prepared by: Troy C. Harrison - Inspector
PROPERTY INSPECTION REPORT

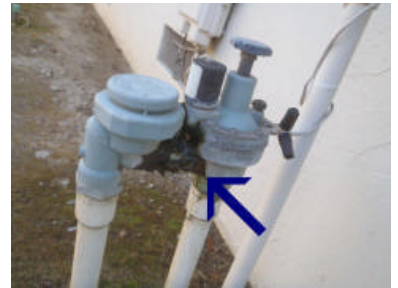
There was leakage observed to the sprinkler valves around the right rear of the house, located below the main panel box. Recommend correction.

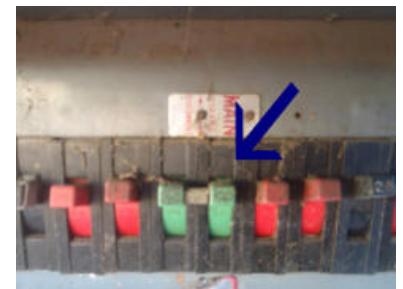
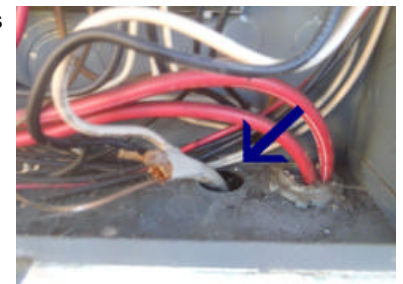
General condition appeared serviceable with the exception of the following: There was an open knock-out and/or missing bushing inside the main panel box. For safety, correction is recommended.

The main electrical panel is manufactured by Zinsco. There have been known documented cases with problems (with the bus bar and circuit breakers) of these types of panels. However, the panel box appeared in good condition, at the time of the inspection with no visible evidence of arcing or overheating. If further detailed information is needed consult with a licensed electrician further evaluation and possible upgrade.

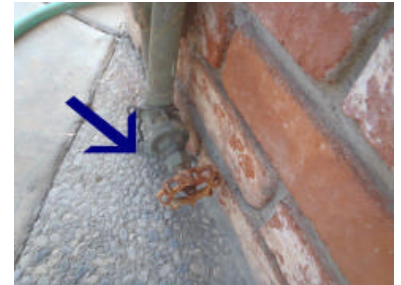
Front of house.

The visible section of the main line appeared serviceable. The majority of the main water piping was underground and its condition could not be determined.

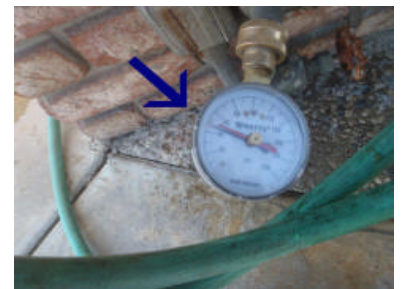
Appeared serviceable. The water pressure tested at approximately 45-50 PSI, which is considered normal (adequate and safe) water pressure.

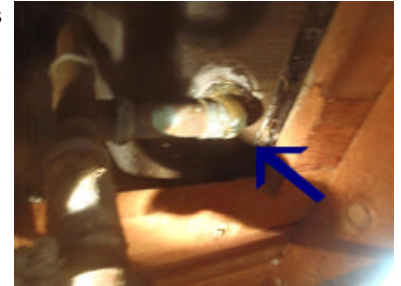
CONDITION:
Water was run through the drain piping to test functional flow and the piping was inspected where visible. General condition appeared serviceable with the exception of the following: There was leakage from the drain line below the hall bathtub (trap arm connection). Recommend correction to prevent possible damage from occurring.

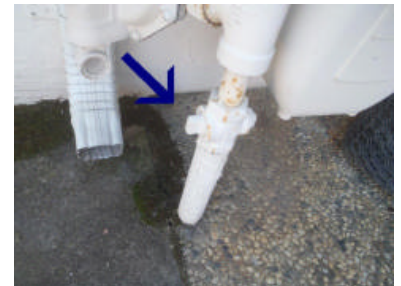
LOCATION:
Right rear.

CONDITION:
System appeared serviceable. However, we recommend installing a automatic safety shut-off valve and/or an earthquake safety wrench at the gas meter, so in the event of an emergency the gas can be shut-off quickly.

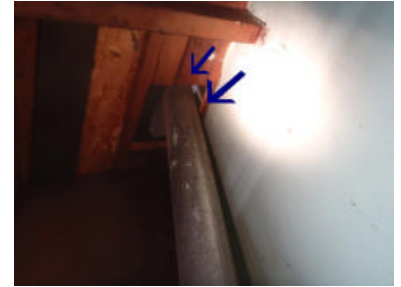
The water heater's flue pipe was in contact with the roof sheathing. We recommend having this corrected, for safety. There needs to be at least 1" inch of annular space between the double wall flue pipe and any combustible materials.

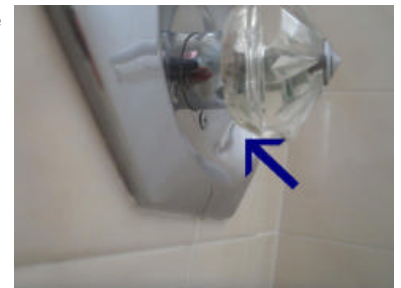
There was leakage observed from the faucet. We recommend repairing or replacing the faucet, for proper operation and to prevent possible water damage from occurring in this area.

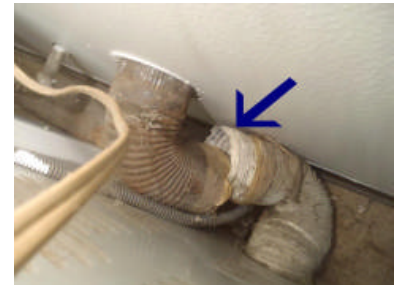
The clothes dryer duct was disconnected behind the dryer. Correction is recommended to prevent moisture and dryer lint build-up in the sub-area.

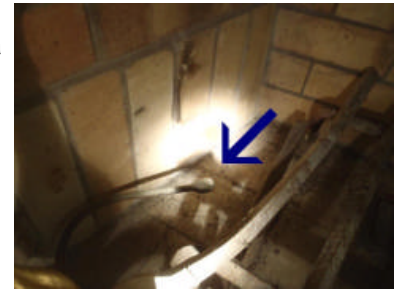
The fireplace appeared serviceable. However, there was an old gas line in the fireplace. The gas line is disconnected and should be removed, for safety. Consult with a licensed fireplace contractor for further evaluation and perform repairs as needed.
