# WOOD DESTROYING PESTS AND ORGANISMS INSPECTION REPORT

BUILDING NO. <b>2925</b>	STREET, CITY, STATE, ZIP <b>Hildalgo Court, San Jose CA 95124</b>	Date of Inspection <b>1/6/2012</b>	No. of Pages <b>6</b>
-----------------------------	--	---------------------------------------	--------------------------

General Description: One story wood/stucco/brick framed stucco exterior, single family residence, occupied with an attached two car garage.	Inspection Tag Posted: Garage
	Other Tags Posted: None noted

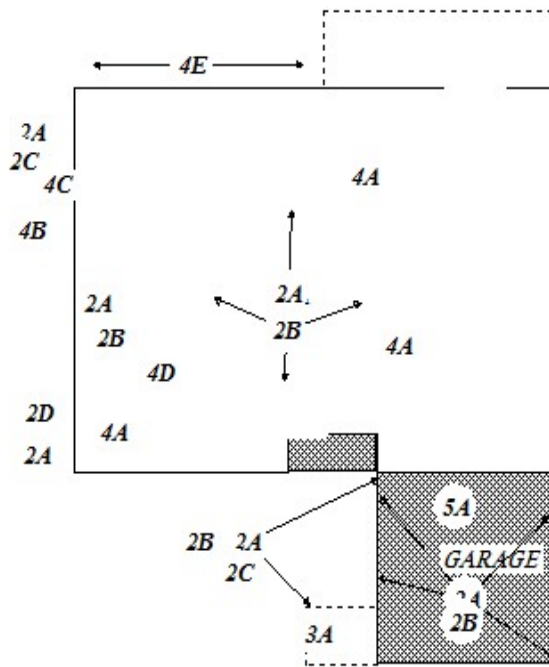
*DIAGRAM NOT TO SCALE*

- ITEM 2A Evidence of drywood termites was noted at the area(s) indicated on the diagram ( Garage/subarea/exterior). Infestation extends into inaccessible area(s).

- ITEM 2B Drywood termite pellets were noted at the areas as outlined in item 2A where indicated on the diagram.

- ITEM 2D Drywood termites have damaged the rafter extensions at areas indicated on diagram.

- ITEM 3A The wood overhang 4x6 support post at area indicated were noted to be in soil contact and fungus damaged.

- ITEM 4A Fungus infected Cellulose debris was noted in the subarea where indicated on the diagram.

- ITEM 4B Vent screen(s) were noted broken or missing where indicated on diagram.

ITEM 4C Hairline stress cracks or missing /broken stucco noted at areas where indicated on diagram.

ITEM 4E A marginal to below grade condition was noted at area indicated on diagram. This condition exists when the soil or concrete at the exterior wall is even with or above the top of the adjacent foundation mudsill or related framing.

RECOMMENDATION: Fumigate the entire structure with Vikane or Zythor gas and Cloropicrin for the complete eradication of drywood termite infestation. This company will furnish all necessary instructions for the owners or concerned parties prior to the fumigation date scheduled.

RECOMMENDATION: Remove and /or mask all accessible termite pellets.

RECOMMENDATION:Remove and/or reinforce damaged extensions as necessary.

RECOMMENDATION: Remove damaged support posts and install either pressure treated material or masonry footing . Lower soil level as necessary.

RECOMMENDATION :Remove the cellulose debris of a rakable size from the subarea and dispose of.

RECOMMENDATION:Replace the broken or missing vent screens.

RECOMMENDATION :Refinish or seal area(s) noted.

RECOMMENDATION :It is recommended that flashing be installed if it does not already exist.
