**1660 Nobili Ave., 3351 Rayanna Ave.
Santa Clara CA 95051**

PROPERTY INSPECTION REPORT

Date: June 14, 2011

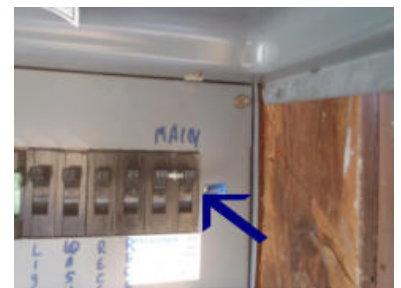
Front right unit #1660.

MAIN PANEL CONDITIONS -

#1660:

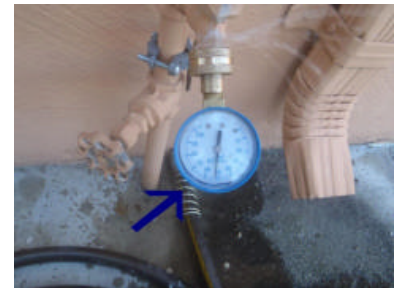
Appeared serviceable-both units. The water pressure tested at approximately 50 PSI, which is considered normal (adequate and safe) water pressure.
